# INSPECTION REPORT

DAMEN SCHELDE MARINE SERVICES

RECONDITIONING

<b>Description:</b>	PISTON CROWN
<b>Engine type:</b>	B&W S60MC
<b>Customer:</b>	
<b>Vessel name :</b>	
<b>Job No. :</b>	603845
<b>DATE</b>	1/29/2010

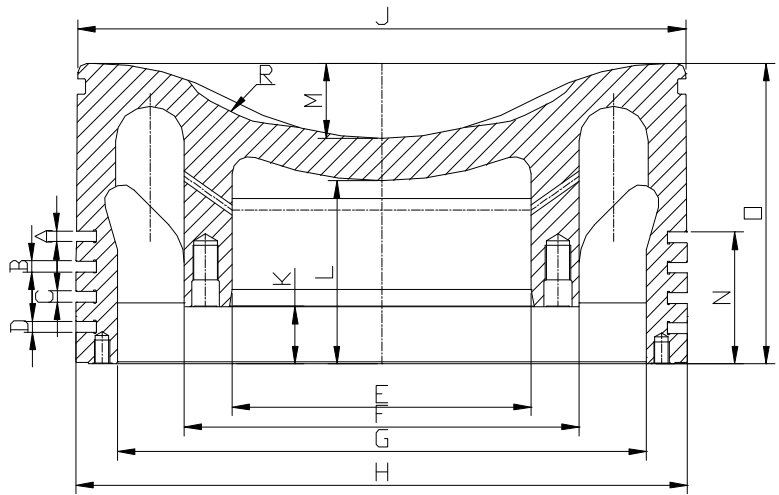
DIMENSION			
	ORIGINAL	BEFORE	AFTER
A	14 +0.29/+0.315	14.55	
B	14 +0.29/+0.315	14.5	
C	11 +0.29/+0.315	11.4	
D	11 +0.29/+0.315	11.4	
E	Ø290 0/+0.10	Ø290.2	
F	Ø385	Ø385.2	
G	Ø505 0/+0.110	Ø505.2	
H	Ø598.4 0/-0.30	Ø598.2	
J	Ø595.5 0/-0.30	Ø595.4	
K	56.5 ±0.10	56.4	
L	194.5	194.3	
M	73	75.4	
N	118.5 ±0.10	118.44	
O	312.5	312.5	
P	12XM24	OK	
Q	16XM16	OK	
R		2.5
